Manhole Inspection Summary

Manhole # S65S__009MH

Insp Date: **8/31/09 1:55 PM**

Location Address: **BROWN AVE.**

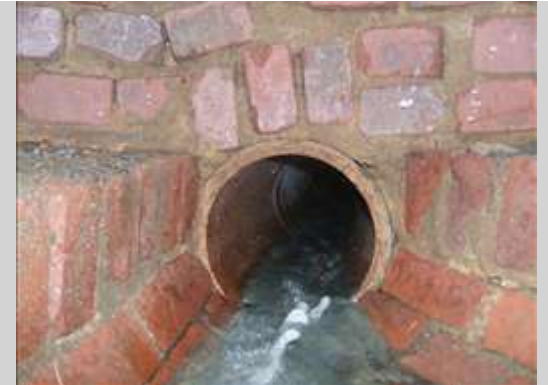
12 O'Clock Outflow

8 in. Circular Gravity Sewer
Pipe Out @ 12 O'Clock

Pipe Height: (in.) Direct
Pipe Material: **Clay** ☐ Pipe Lined
Invert Depth: **8.07** (ft.) Flow Characteristics: **Slow**
Deposits: ☒ None ☐ Mud ☐ Sludge ☐ Debris ☐ Grease
Silt Depth: (in.) Deposits Extent:
Infiltration: **Evidence** Pipe Seal Cond: **Cracked**

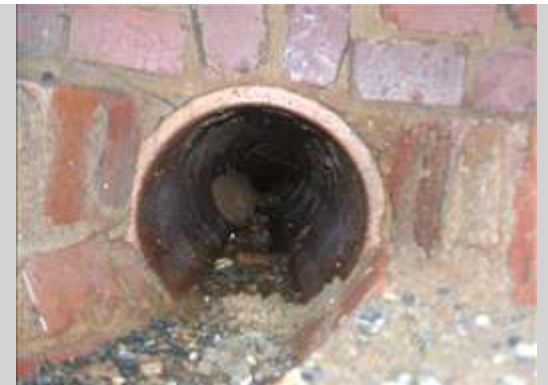
3 O'Clock Inflow

8 in. Circular Gravity Sewer
Pipe In @ 3 O'Clock

Pipe Height: (in.) Direct
Pipe Material: **Clay** ☐ Pipe Lined
Invert Depth: **8.02** (ft.) Flow Characteristics: **None**
Deposits: ☒ None ☐ Mud ☐ Sludge ☐ Debris ☐ Grease
Silt Depth: (in.) Deposits Extent:
Infiltration: **None** Pipe Seal Cond: **Sound**

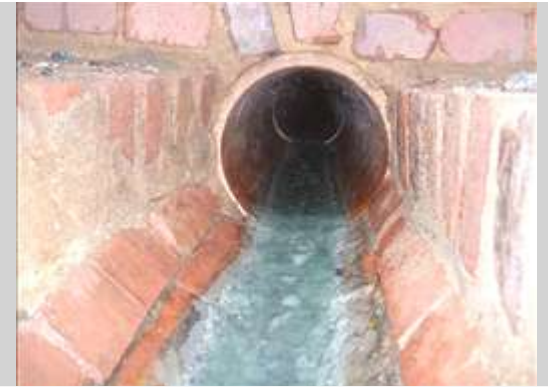
6 O'Clock Inflow

8 in. Circular Gravity Sewer
Pipe In @ 6 O'Clock

Infiltration: **None** Pipe Seal Cond: **Sound**
